MANIFOLD HOUSE

337 E. 244th St.

Overview

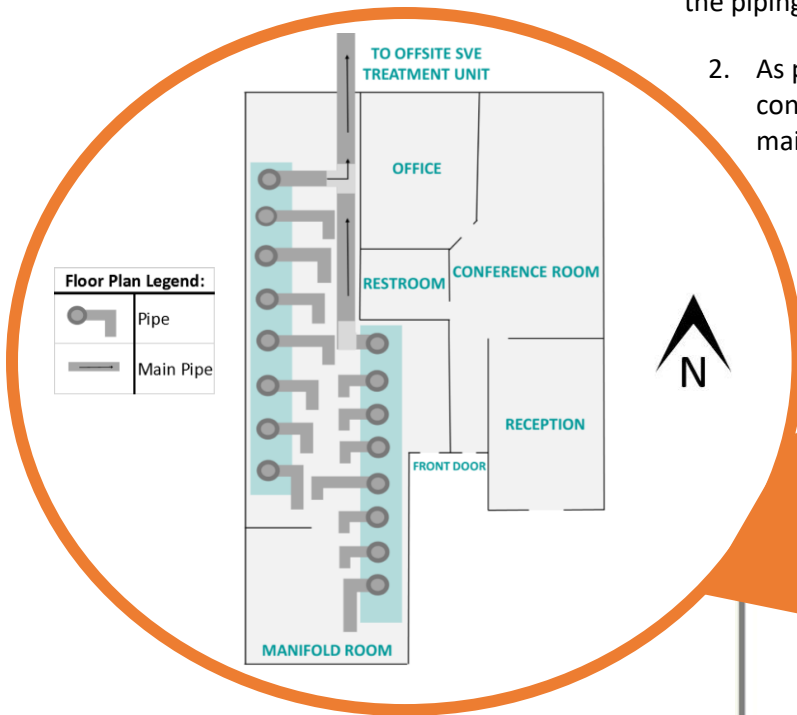
Manifold House Floor Plan

1. Extracted gases are directed to a series of pipes which lead to the piping manifold.
2. As part of the SVE system, a piping manifold is required to convert the multiple pipes throughout the tract into one main pipe.
3. The main pipe located within the manifold house, will then leave the tract to an offsite treatment facility.

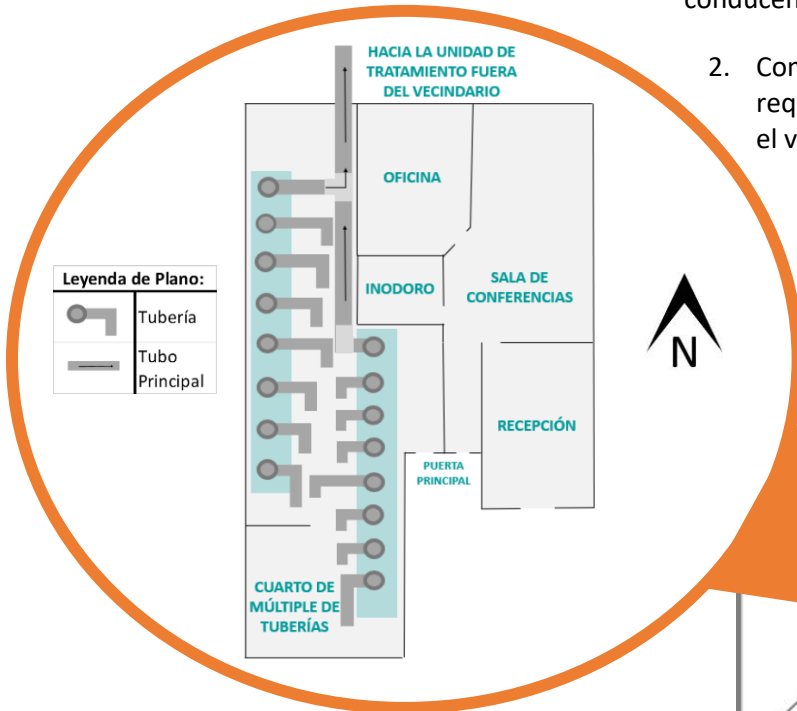
Plano de Casa

1. Los gases extraídos se dirigen a una serie de tuberías que conducen a la casa de múltiple de tuberías.
2. Como parte del sistema SVE, un múltiple de tuberías se requiere para convertir las numerosas tuberías de todo el vecindario en una tubería principal.
3. La tubería principal dejará el sitio a una instalación de tratamiento fuera del vecindario.
